January 18, 2024

Re: Sea Island South Condominium IV

Structural Integrity Reserve Study (SIRS) 750 Island Way, Clearwater, Florida 33767 UES Project No: 0811.2300027.0000 – Task 14

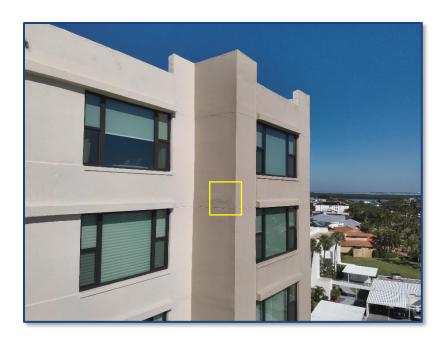
The exterior finish of the building consists of painted stucco finishes. Isolated cracks in the exterior stucco finishes were observed on the east elevation. The overall condition of the exterior finishes was observed to be in good condition.

Photograph No. 5: Cracks in the stucco finishes on the east elevation.

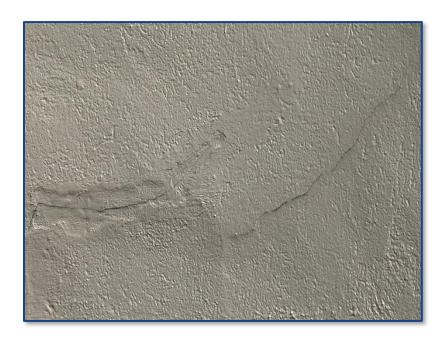
Photograph No. 6: Close-up view of Photograph No. 5.

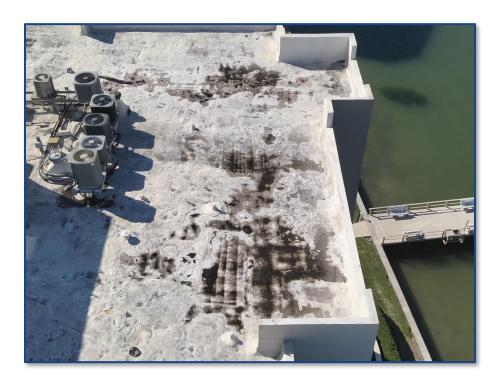
The roof system of the building is composed of a Polyurethane roof system which was recoated in 2014. At the time of inspection, ponding was observed in multiple areas, significant deterioration was observed in the roof membrane in multiple areas, and air bubbles in the roof membrane were also observed. Overall, the roof was observed to be in poor condition. UES was informed that bids are currently being accepted for a new roof to be installed in the spring of 2024. UES was informed that the new roof would be a thermoplastic polyolefin (TPO) roof system.

Photograph No. 14: View of ponding stains in the roof membrane.

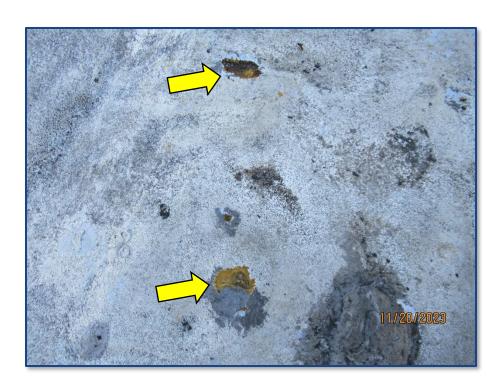
Photograph No. 15: View of deterioration in the roof membrane.

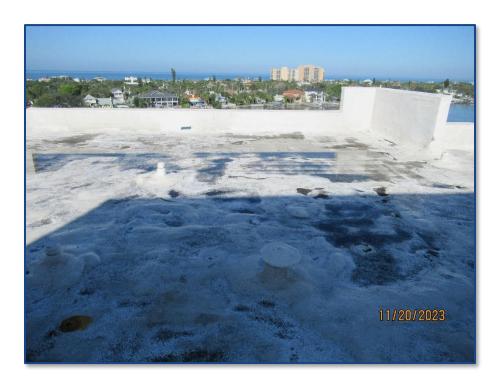
Photograph No. 16: View of ponding on the roof.

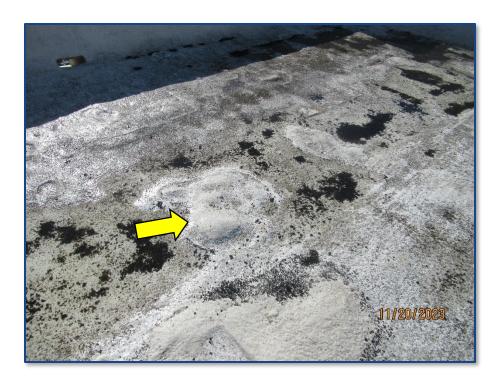
Photograph No. 17: View of bubbling in the roof membrane.

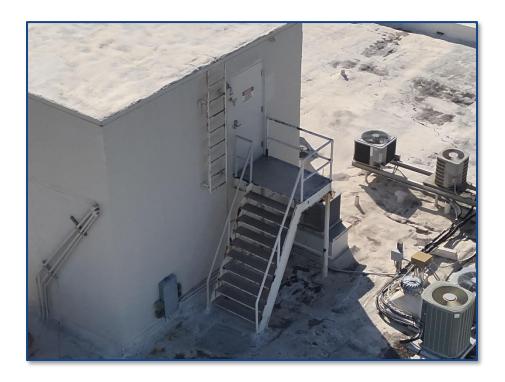
Photograph No. 18: General view of the vertical fixed steel ladder and steel stairs.

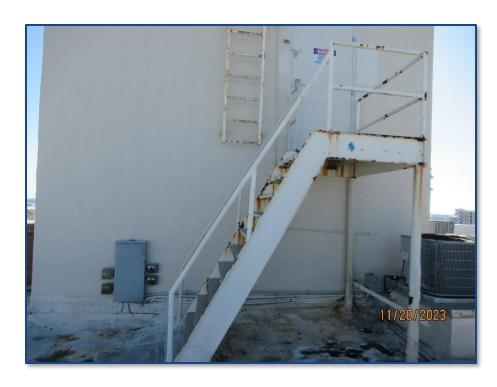
Photograph No. 19: View of corrosion in the steel framing stairs and vertical fixed ladder.

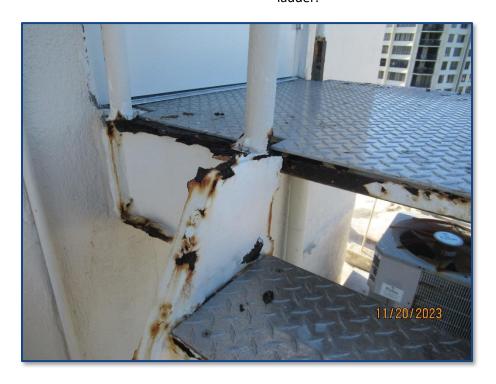
Photograph No. 20: View of significantly corroded steel stair framing members.

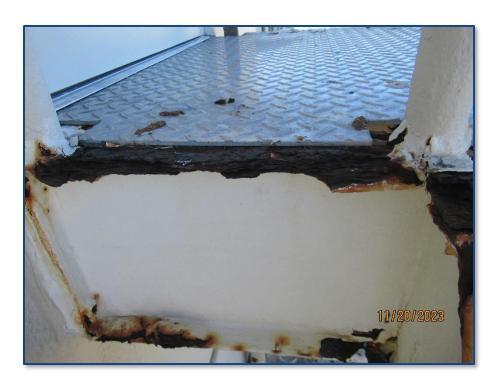
Photograph No. 21: View of significantly corroded steel stair framing members.

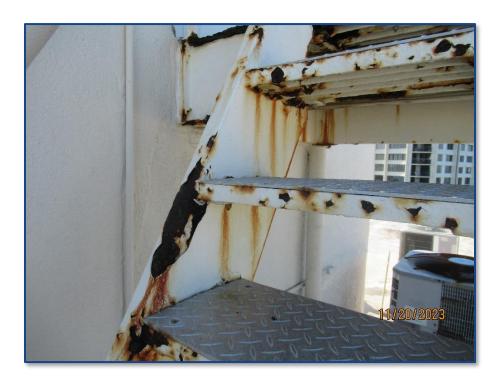
Photograph No. 22: View of significantly corroded steel stair framing members.

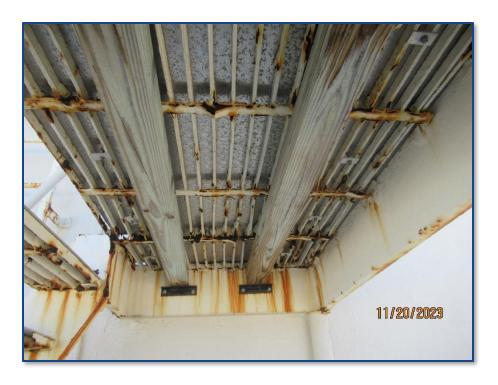
Photograph No. 23: View of significantly corroded steel stair gratings.

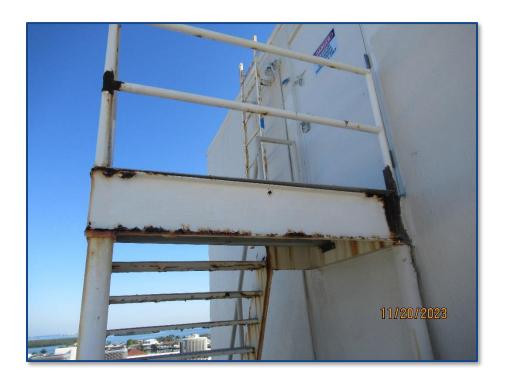
Photograph No. 24: View of significantly corroded steel stair framing members.

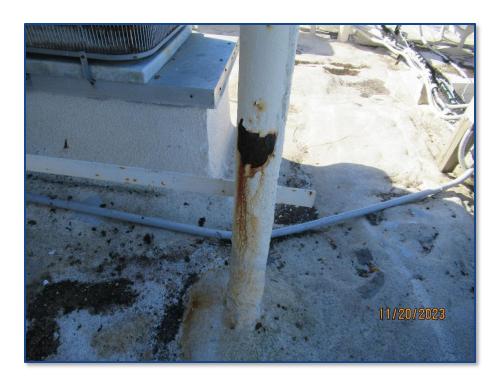
Photograph No. 25: View of significantly corroded steel stair framing post.

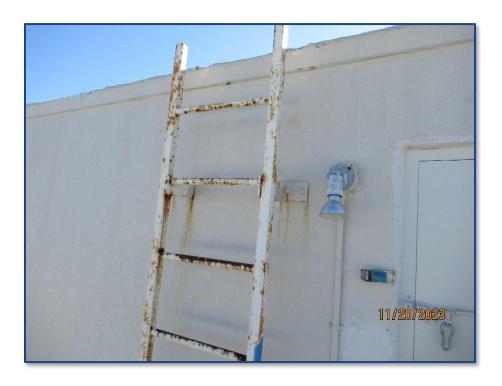
Photograph No. 26: View of significantly corroded steel ladder framing members.

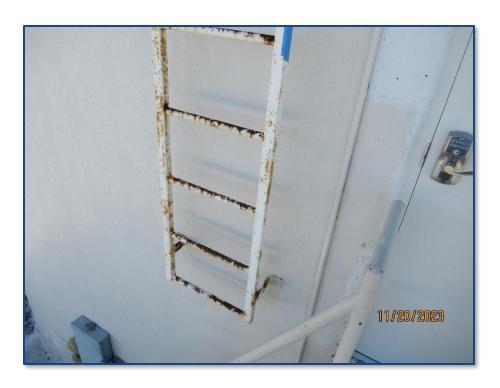
Photograph No. 27: View of significantly corroded steel ladder framing members.
